## A Survey of Thatched Buildings in Scotland

Thatch Survey of Scotland  
2014-15

A photographic survey of thatched buildings in Scotland, surveyed between May 2014 and August 2015 by Zoe Herbert (SPAB Scotland Officer), on behalf of the Society for the Protection of Ancient Buildings.

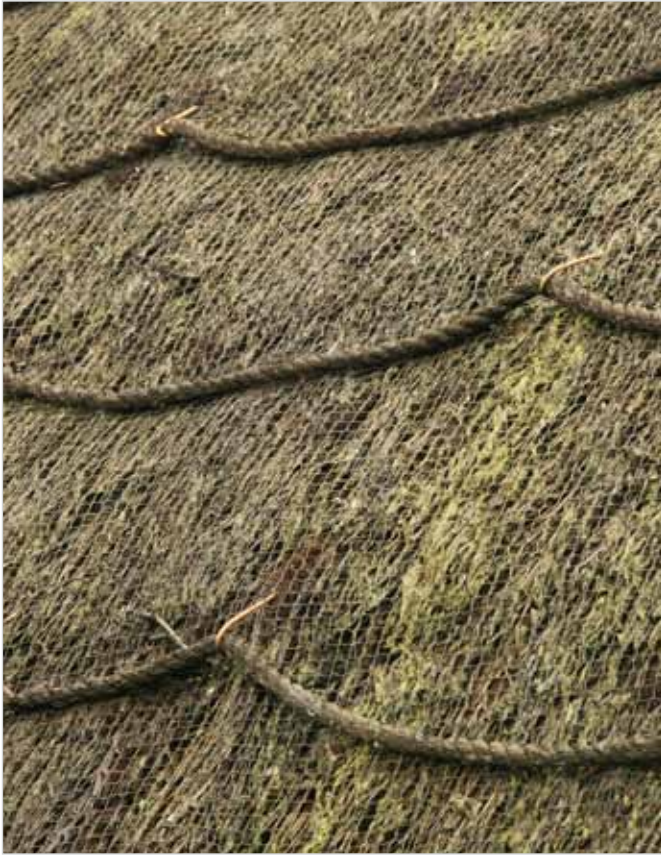
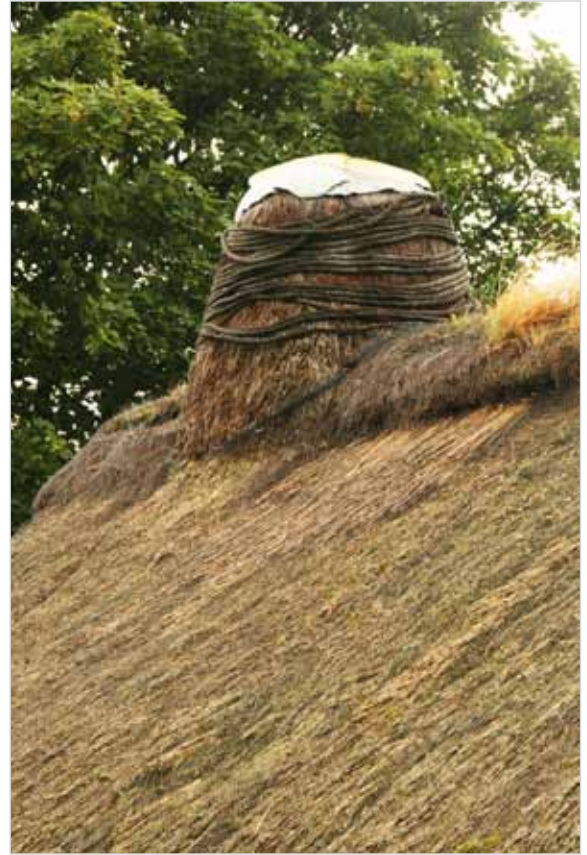
The Cruck Cottage – Dumfries & Galloway

Additional Notes: ..... Single-storey cruck-frame cottage, largely rebuilt in the first half of the 19th century. It was damaged by fire in 1956 and was restored and re-thatched in 1960. Major restoration work was also carried out in 1991-93, however, by 2003 the thatch had deteriorated quite badly in places and so the top layer of thatch was removed, along with some of the rotten timbers. It was then covered with a new layer of rye straw and the chimney was re-thatched in heather and secured with rope. At this time the ridge was also finished with woven straw. By 2012 several areas on the front of the roof were showing signs of rot and so repairs were carried out in November of that year. The ropes securing the thatch at the front were found to be rotten and were removed. This time, the ridge was repaired using heather turf. It was estimated at the time that these repairs would keep the roof watertight for at least another four years (circa 2016), at which time a total re-thatch would be required. Due to the high cost of rope, it was decided that replacement ropes for the front of the roof could not be justified at the time and would be replaced instead during the complete re-thatching. The Cruck Cottage Heritage Association that has been set up locally carries out the basic year-to-year maintenance and repair to the building. All the restoration work in recent years has been carried out and/or organised by thatcher Jeremy Cox, based in Castle Douglas. (Information provided by the Cruck Cottage Heritage Association.) The cottage

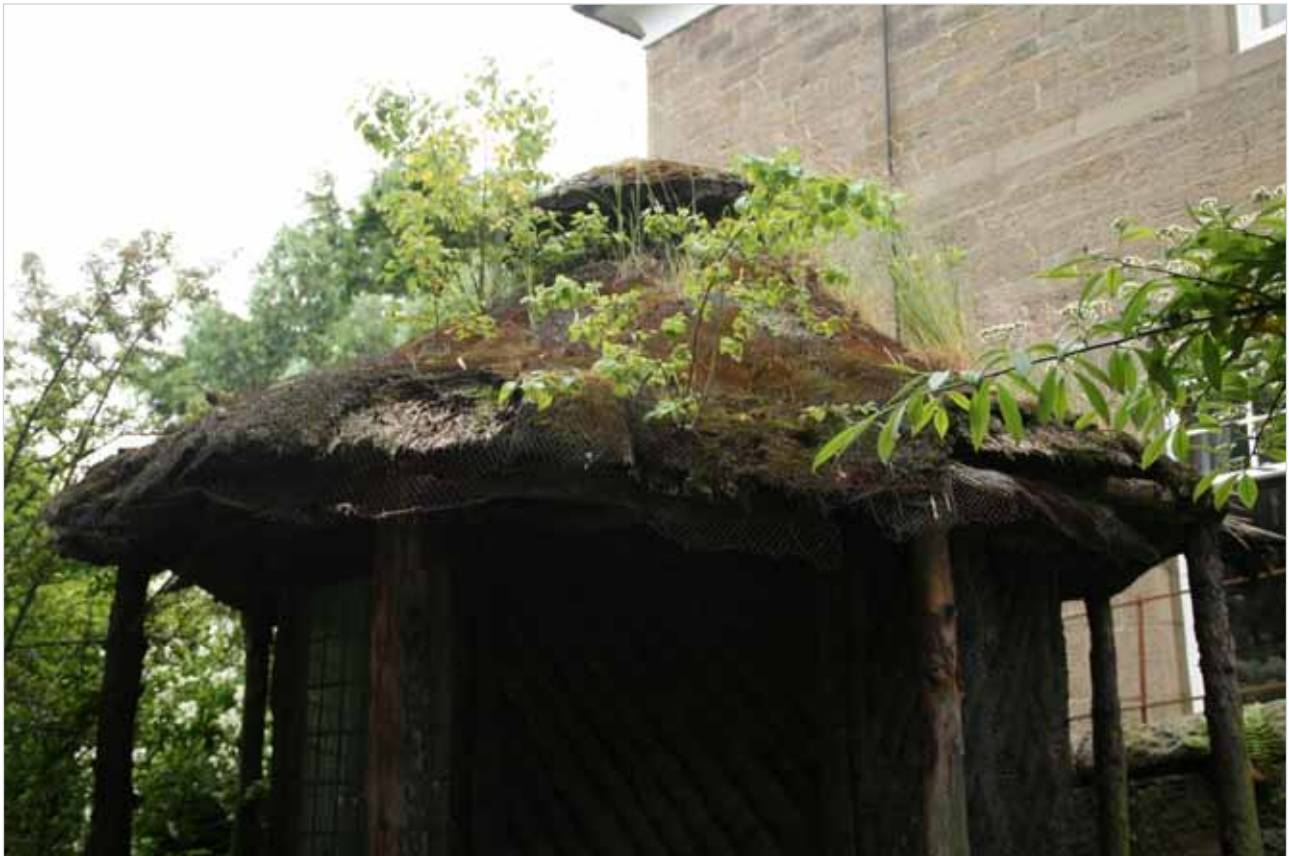
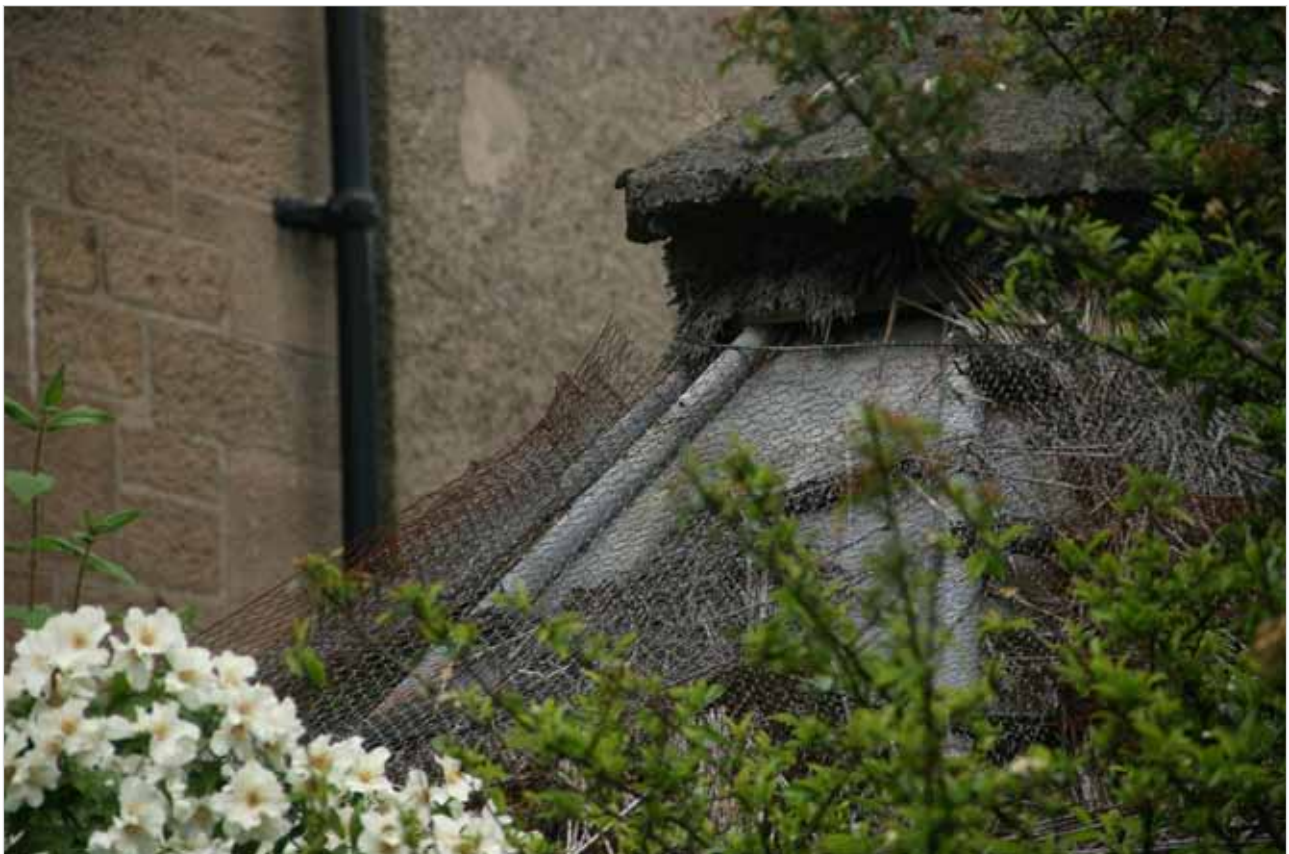
Pinemount – Dundee

Condition of Thatch: ..... Poor

completely restore the structure, including the thatch, which is currently in a fairly bad condition, at some point

this year. The roof on the structure is in a particularly poor condition, with the thatch being missing or loose

where the thatch is missing you can see a lead

the entire roof underneath the thatch. The roof

has a concrete capping.

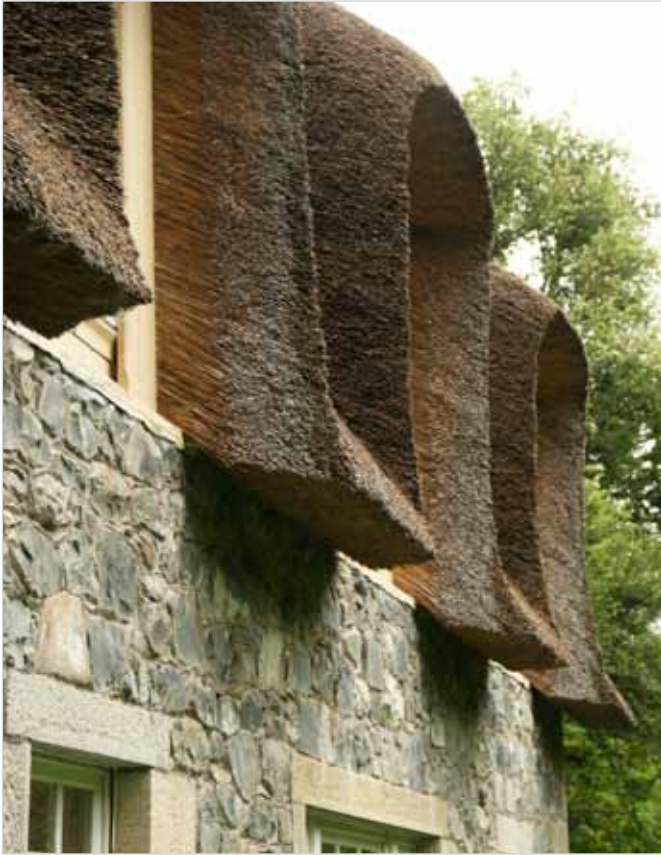
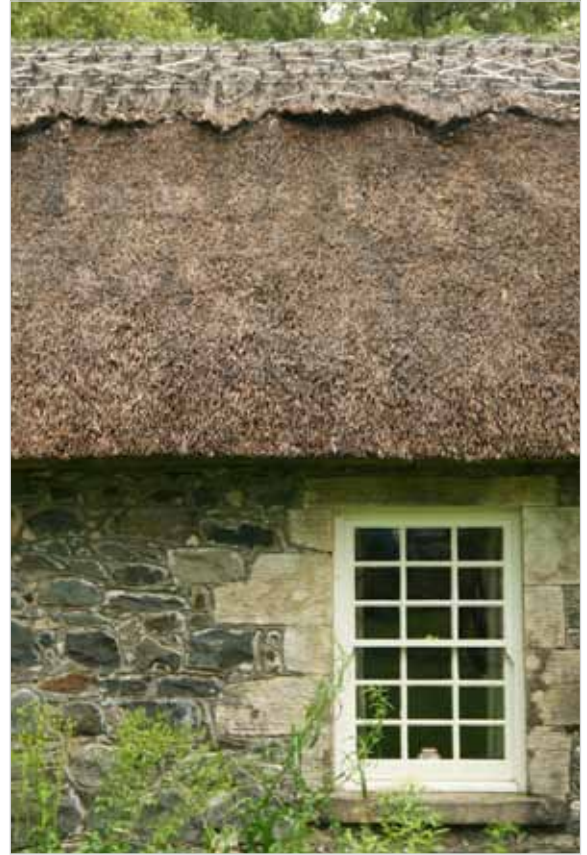
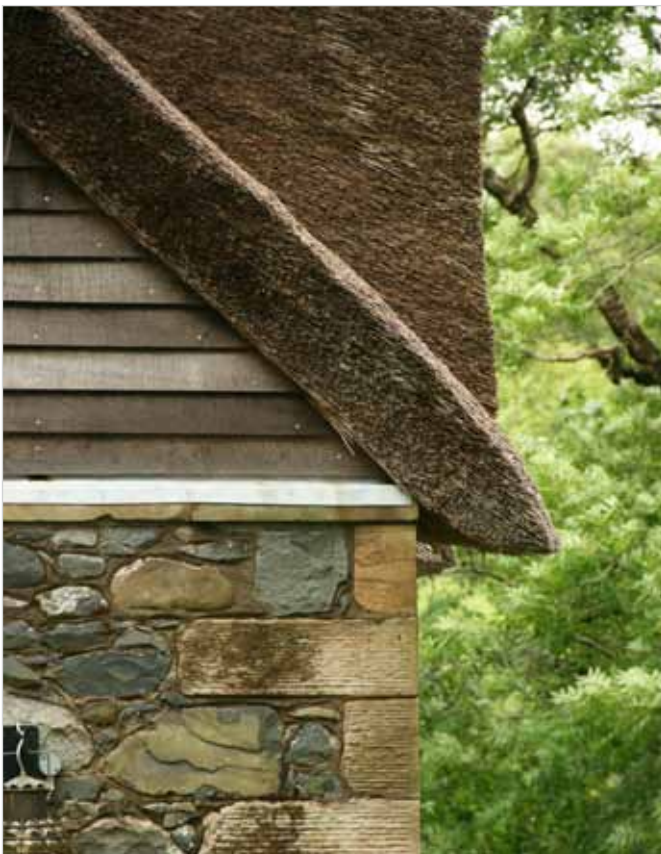
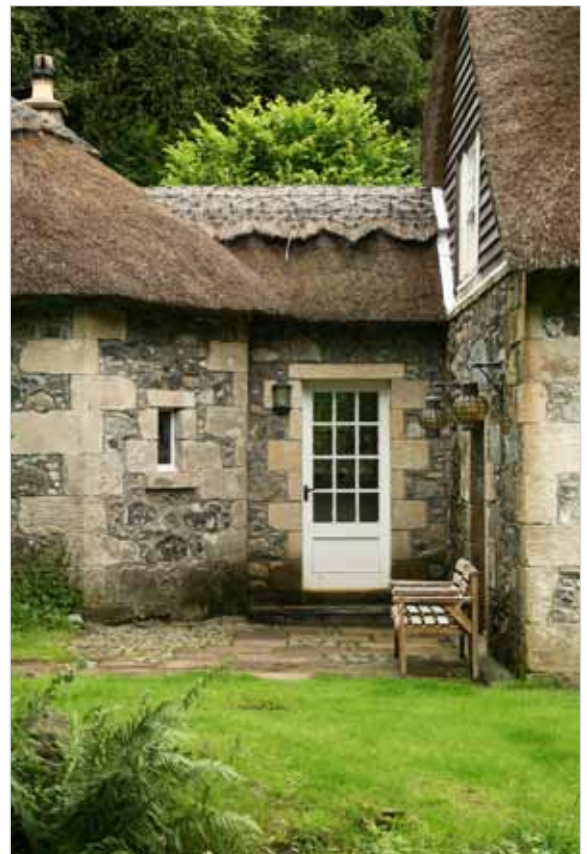
Forget Me Not Cottage – East Ayrshire

Condition of Thatch: ..... Good

Additional Notes: Large restored two-storey cottage with single-storey wing to the west, which is currently in use as holiday accomodation. The roof has a reed sculpted raised ridge, which has been scobed using hazel spars and has been netted. The rest of the reed-roof has been left uncovered. The roof of the main building has three large dormer windows along the front elevation of the building. The thatch is in good condition, however, the ridge is in need of some maintenance.

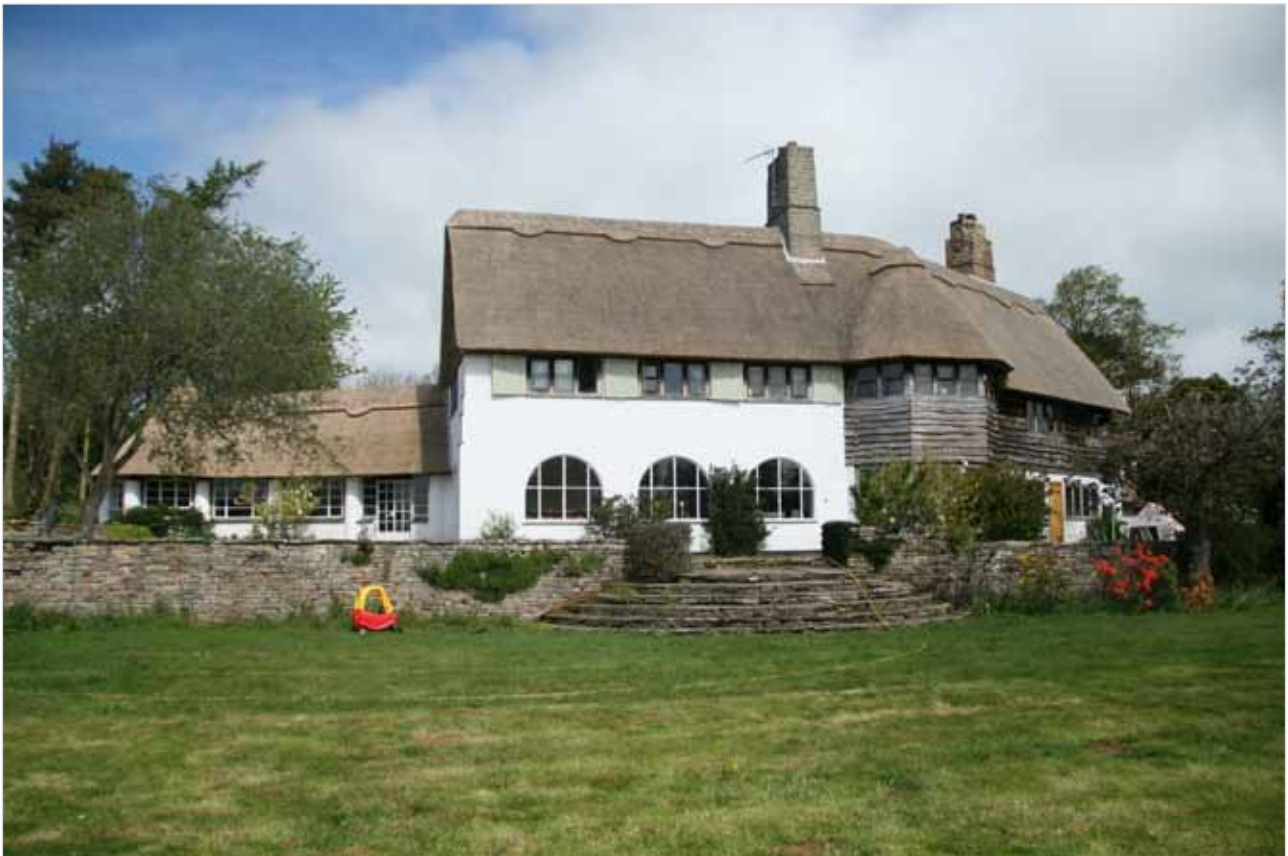
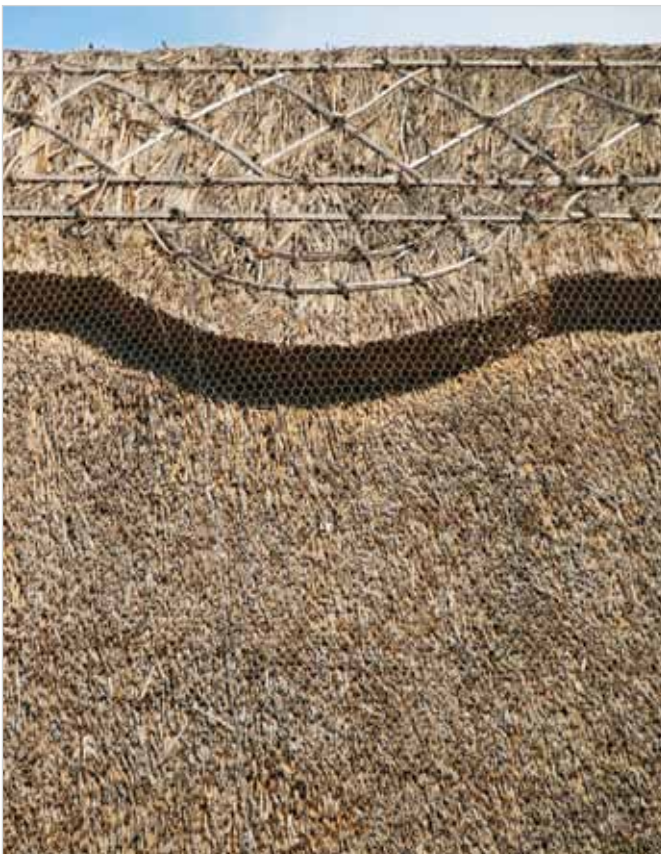
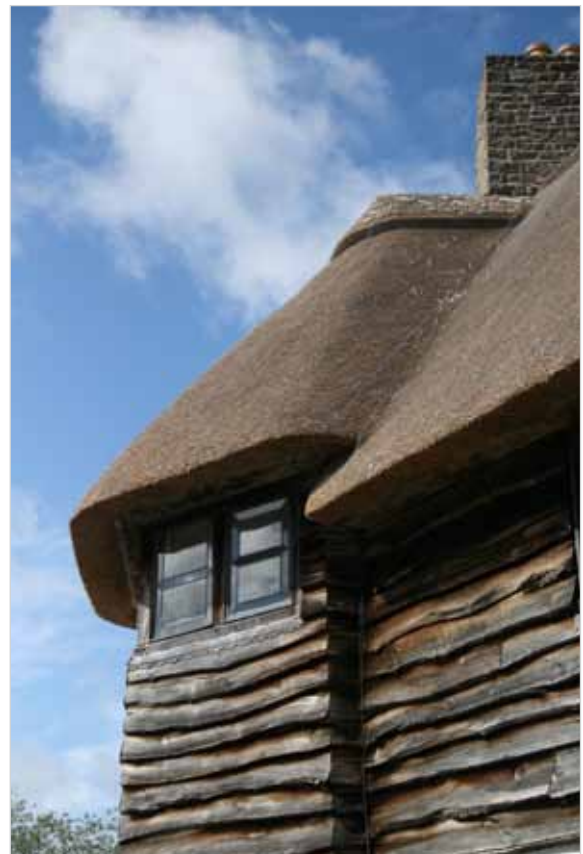
Bolton Muir – East Lothian

Condition of Thatch: ..... Good

**Additional Notes:** ..... Arts and Crafts style single-storey plus attic mansion, built in 1930. Attached to the main building is a single-storey plus attic piend lodge, with flanking garage entrance with thatched coping and drum piers with conical thatched caps. The current building owner states that the building has been re-thatched within the last six months using Norfolk reed. The ridge is thatched, sculpted decoratively at the base and scobed with what appear to be hazel spars. The entire roof is netted, including over the ridge.

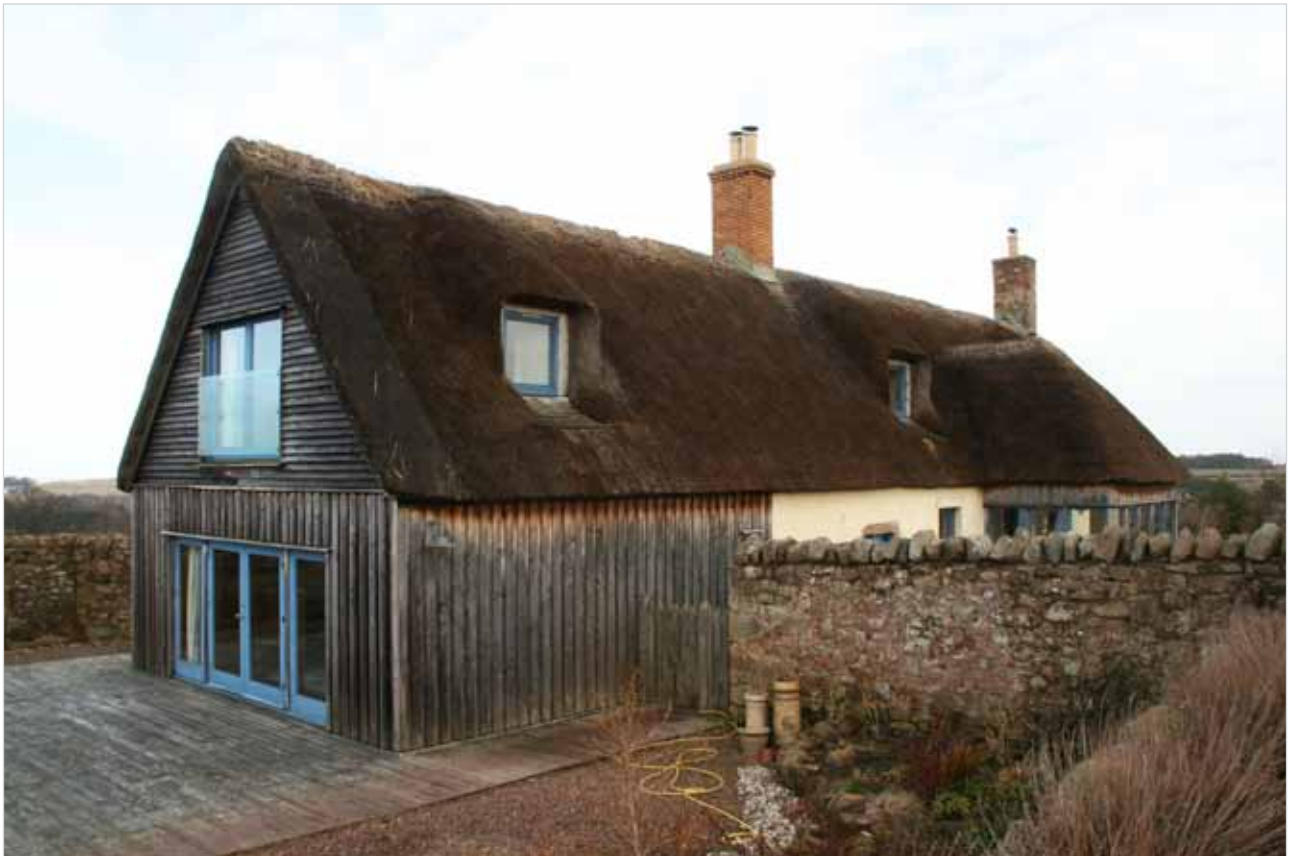
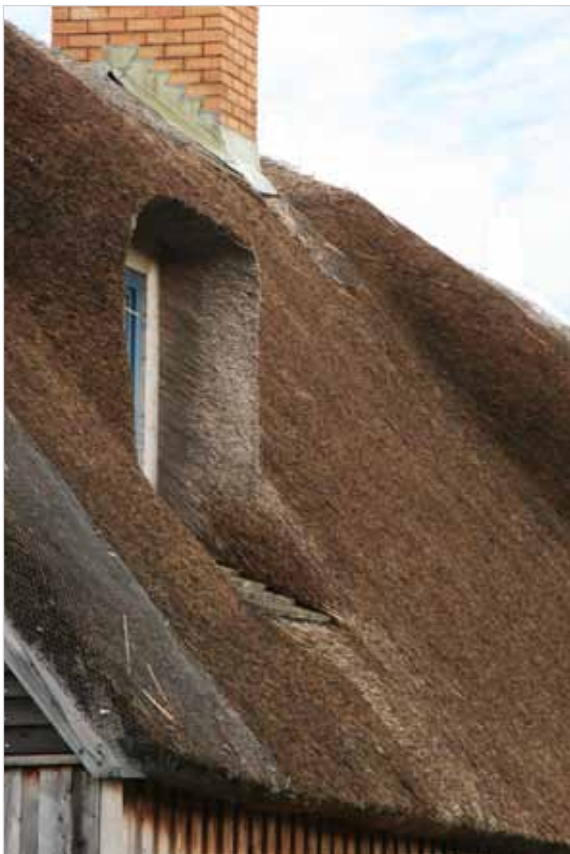
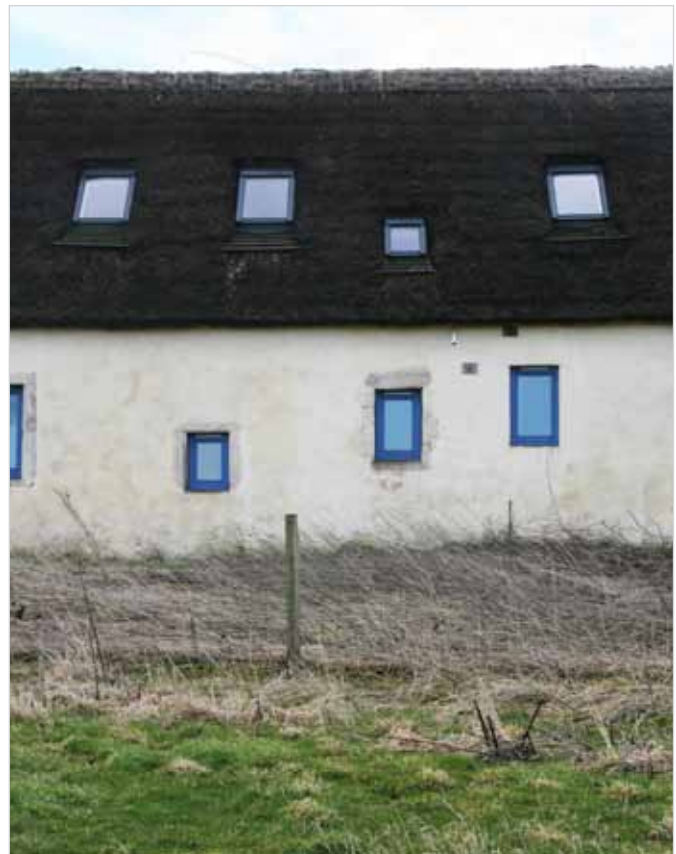
Park Cottage – East Lothian

Condition of Thatch: ..... Good

after storms and wind had caused the ridge to deteriorate. At this time, the skewers at the west end were also

netted to prevent further deterioration and some of the thatch below the left dormer window was repaired. This

ridge is due to be repaired and the whole roof

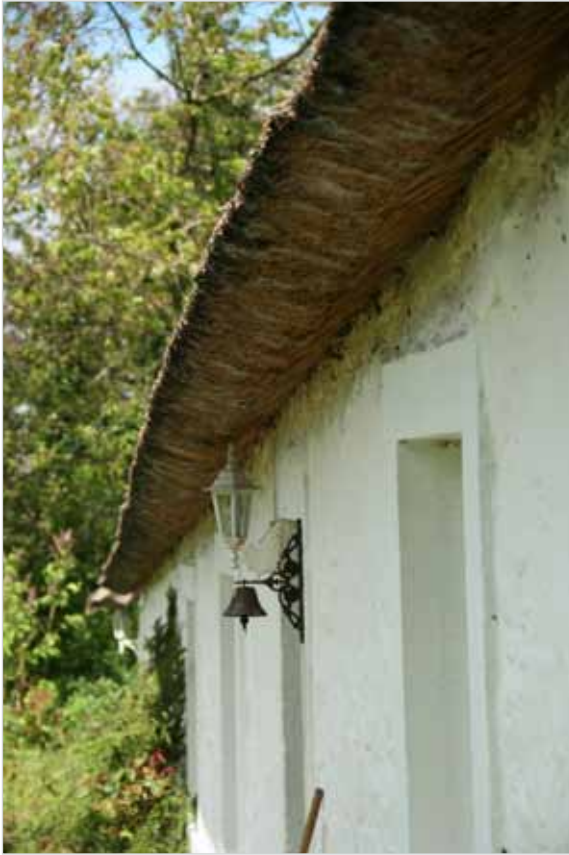
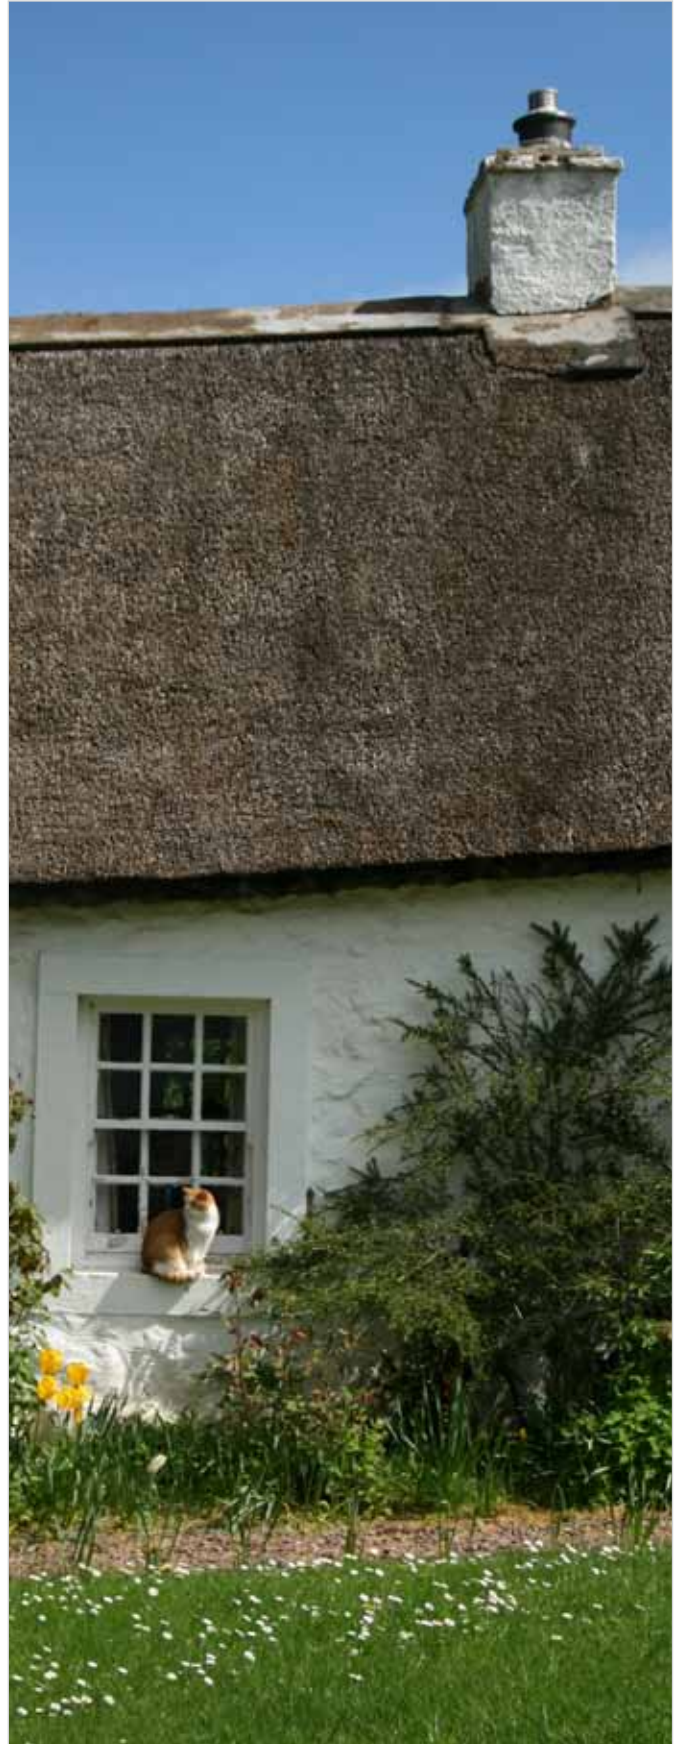
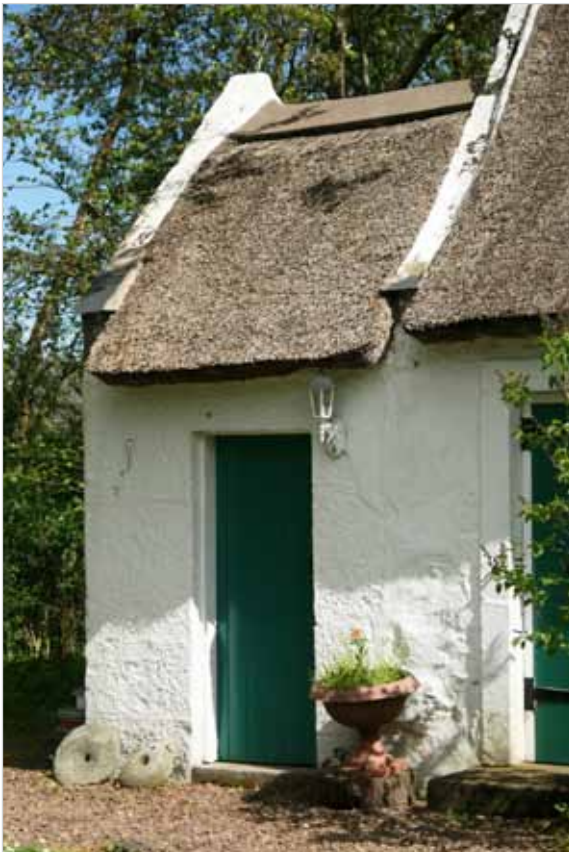
9-10 Swanston Village – Edinburgh

Condition of Thatch: ..... Good

**Additional Notes:** ..... 18th-century single-storey cottage building, comprising two properties, with a continuous  
thatch roof and concrete ridge spanning. It is noted on the listed building entry that it would have once consisted  
of three cottages, with the current number 9 originally being two properties. There are two small later extensions  
at either end of the building that are also thatched. The listing states they were restored in 1959-62 by J Wilson  
Paterson for Edinburgh Corporation. The owner of number 10 noted that the whole building had last been  
thatched in Norfolk reed in around 2007. None of the thatch is netted. The cottages are part of the small village

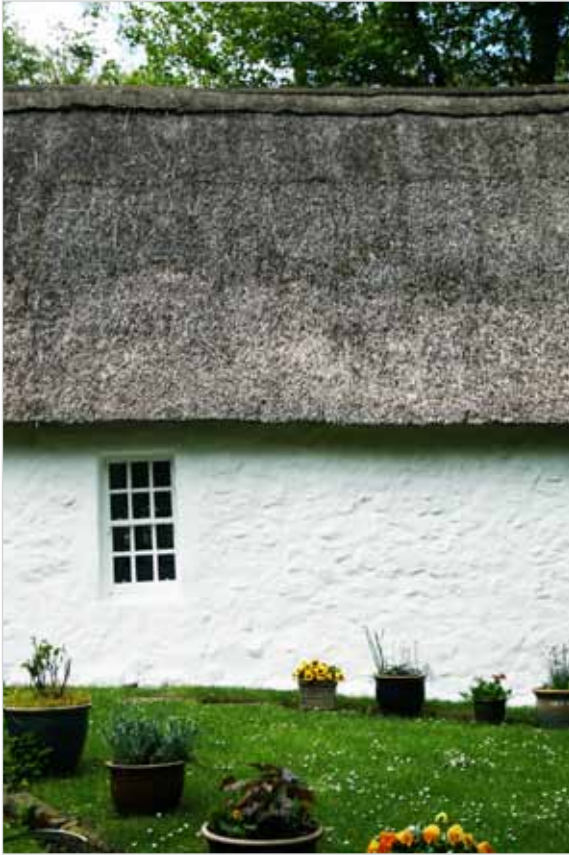
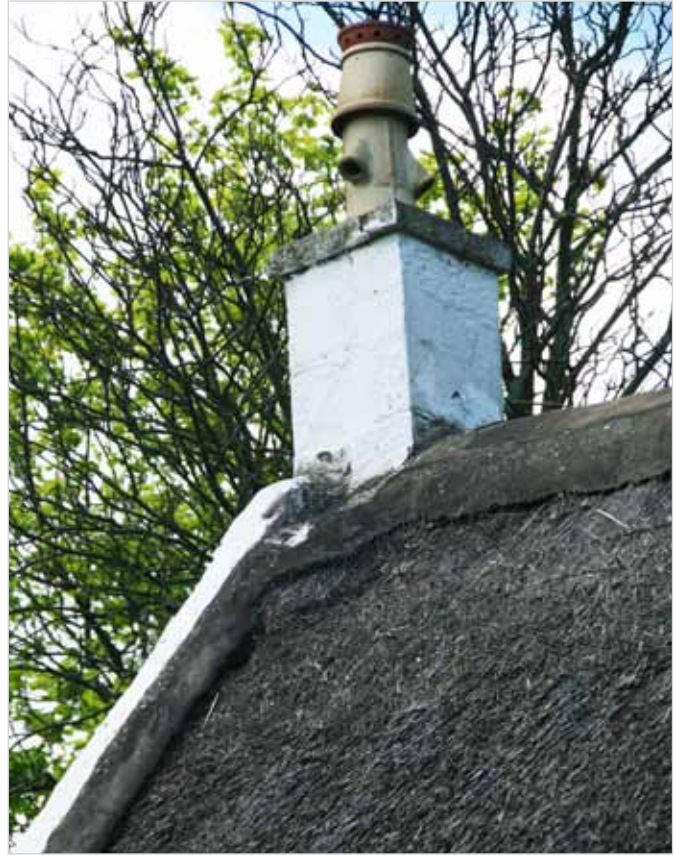
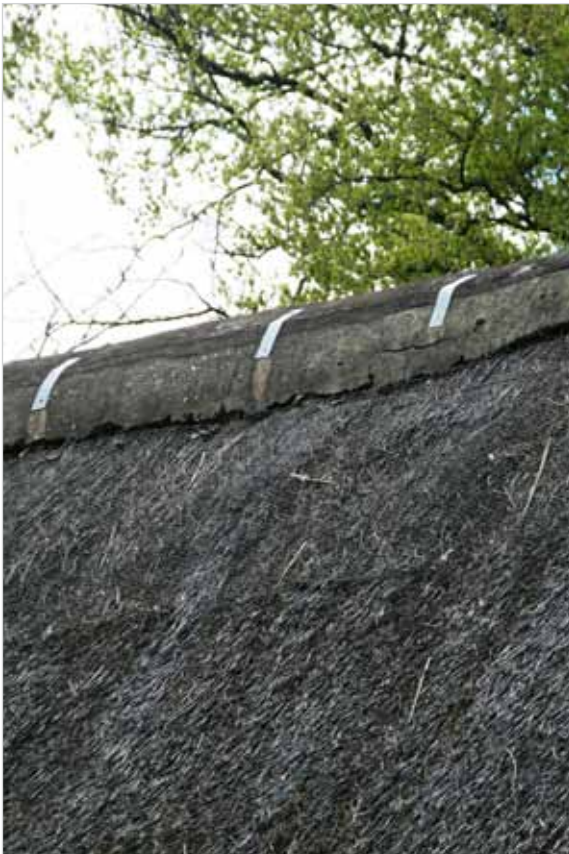
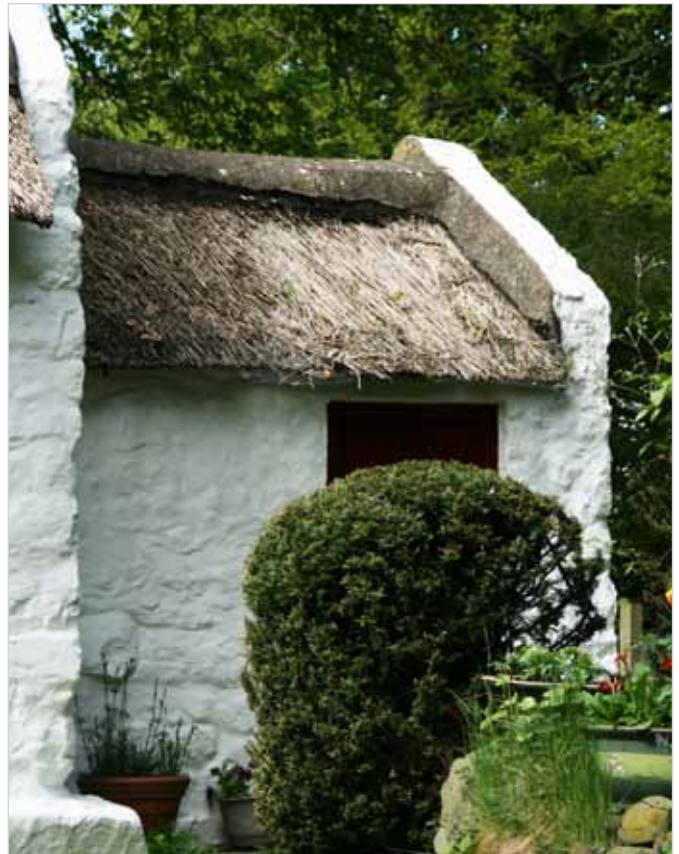
Address: ..... 11 Swanston Village

Condition of Thatch: ..... Fair

concrete ridge has experienced some deterioration, so much so that six metal ties have been installed along the

front, presumably where significant cracks were present. The thatch is only partially netted, for a few feet below

left around the sides. The thatch has deteriorated

slightly in places; there are a few loose reeds

though this could be partly due to deterioration

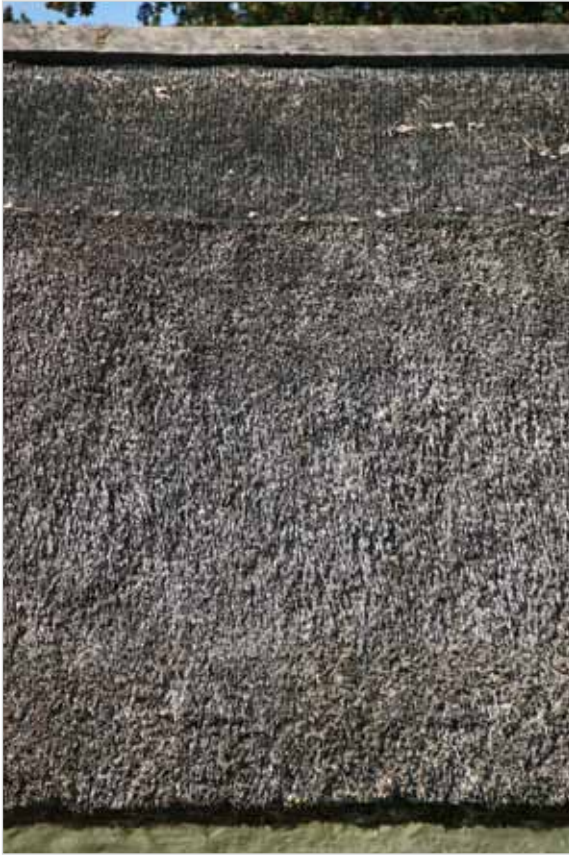
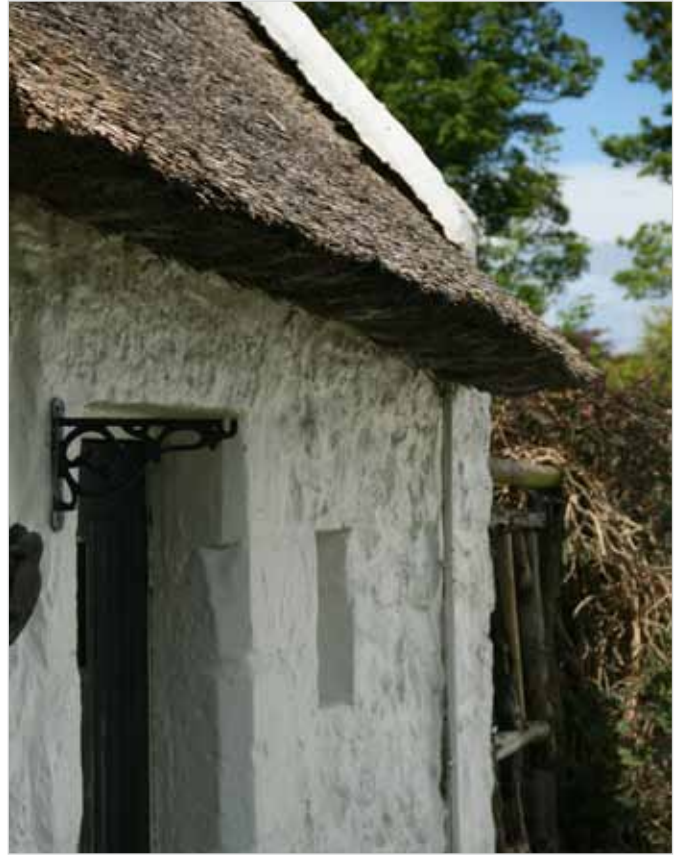
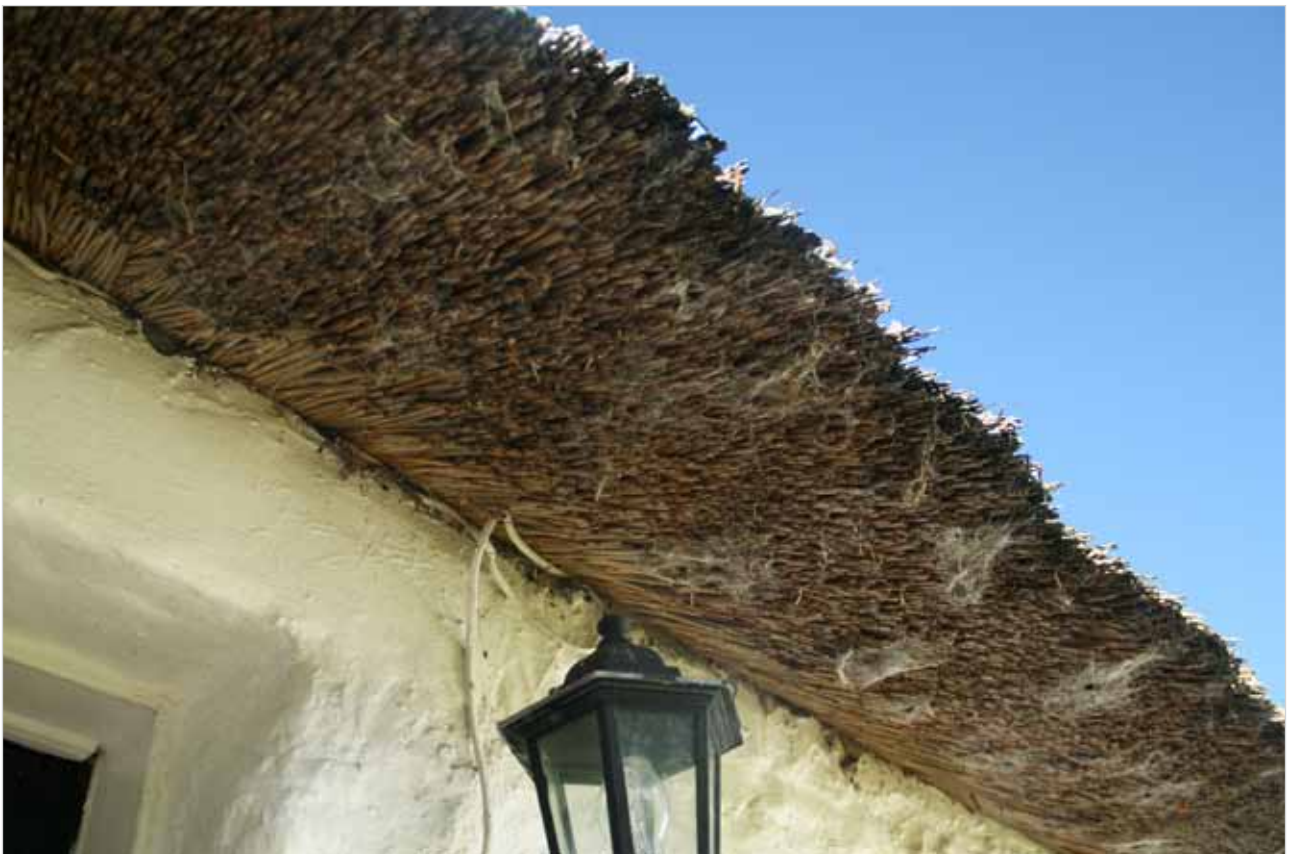
12 Swanston Village – Edinburgh

Condition of Thatch: ..... Good

**Additional Notes:** 18th-century cottage, listed as being 'restored by J Wilson Paterson for Edinburgh Corporation 1959-62'. The owner states that the roof was last thatched approximately eight years ago using a Tay reed. The thatch remains in a good condition, as does the concrete ridge, with only a small patch of mossy vegetation growth near the top of the thatch visible on the front elevation. The thatch is netted below the ridge only, for about a foot in width. The rest of the thatch is left uncovered. Part of a group of thatched cottages of the same period (see surveys 059-060 and 062-064).

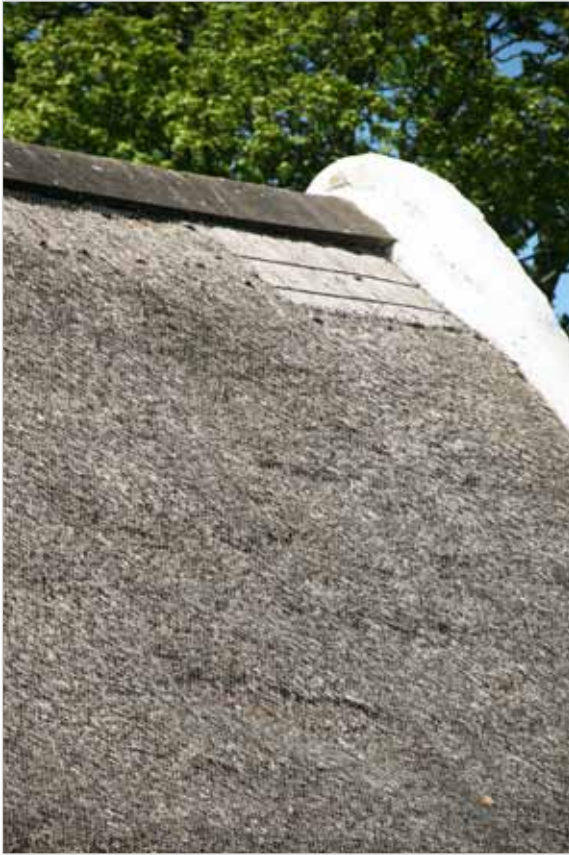
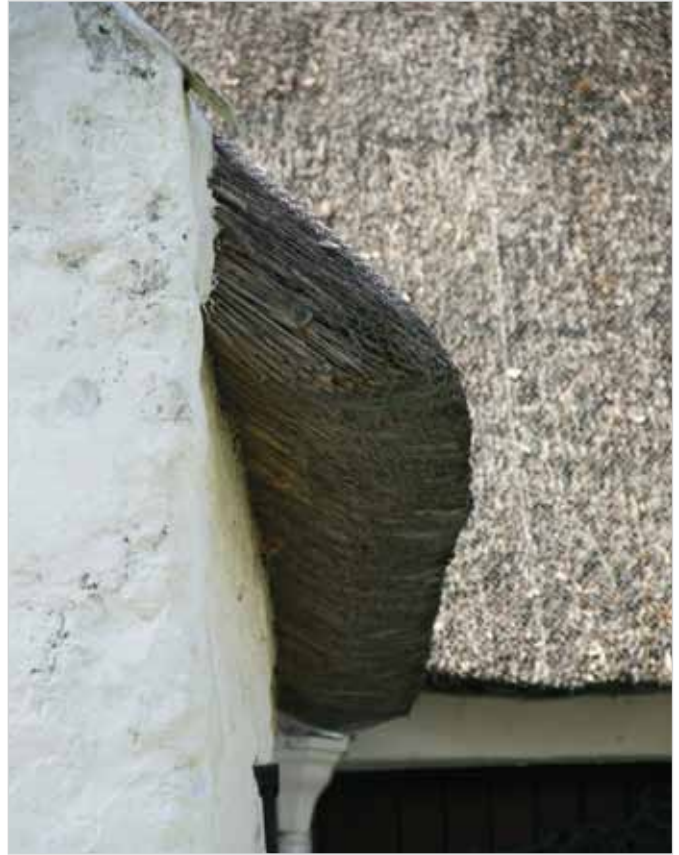
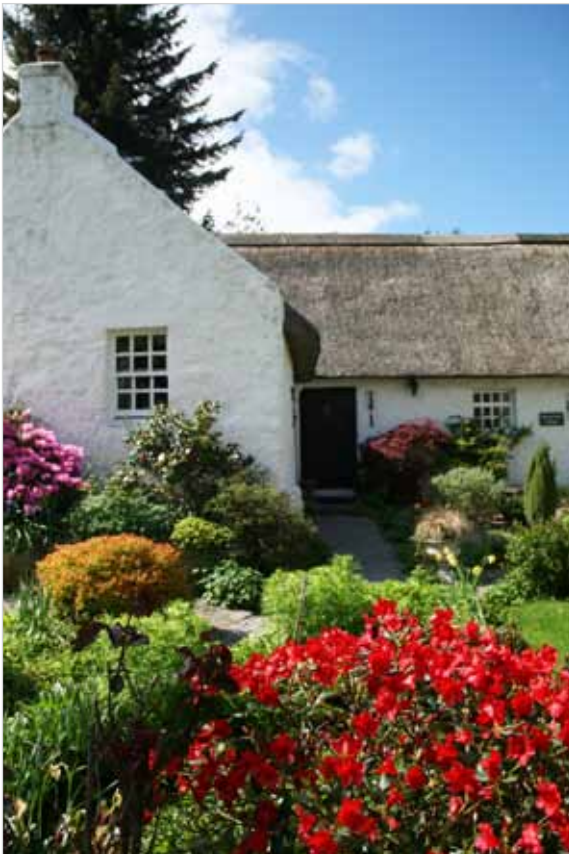
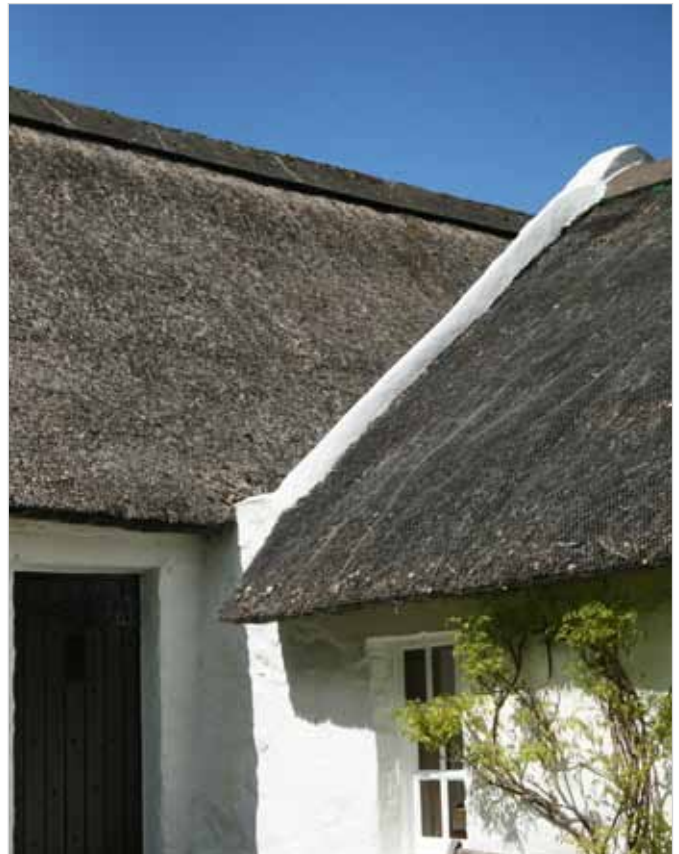
13 and 14 Swanston Village – Edinburgh

Condition of Thatch: ..... Good

The concrete ridge appears to have been repaired, as a section in the middle looks to have been entirely replaced.

There has also been a repair to the thatch, in the top right corner of the principal elevation on the main cottage,

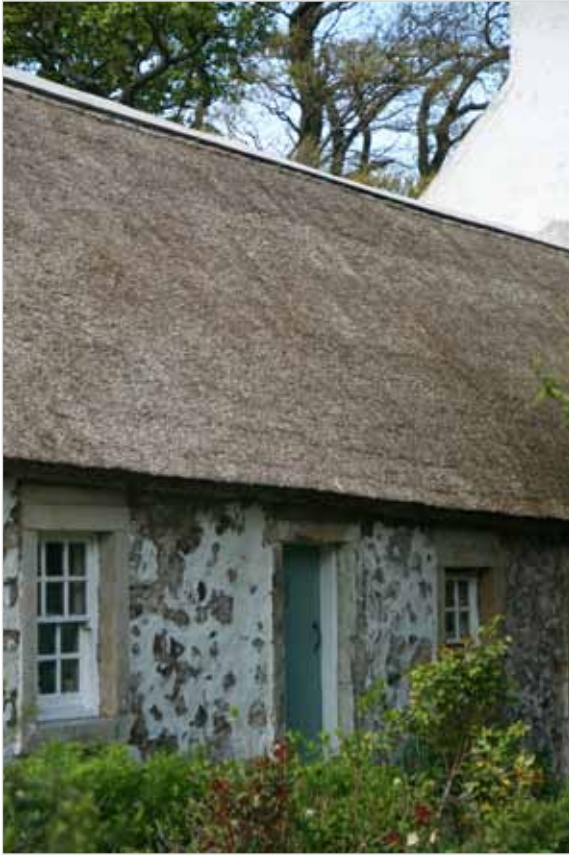
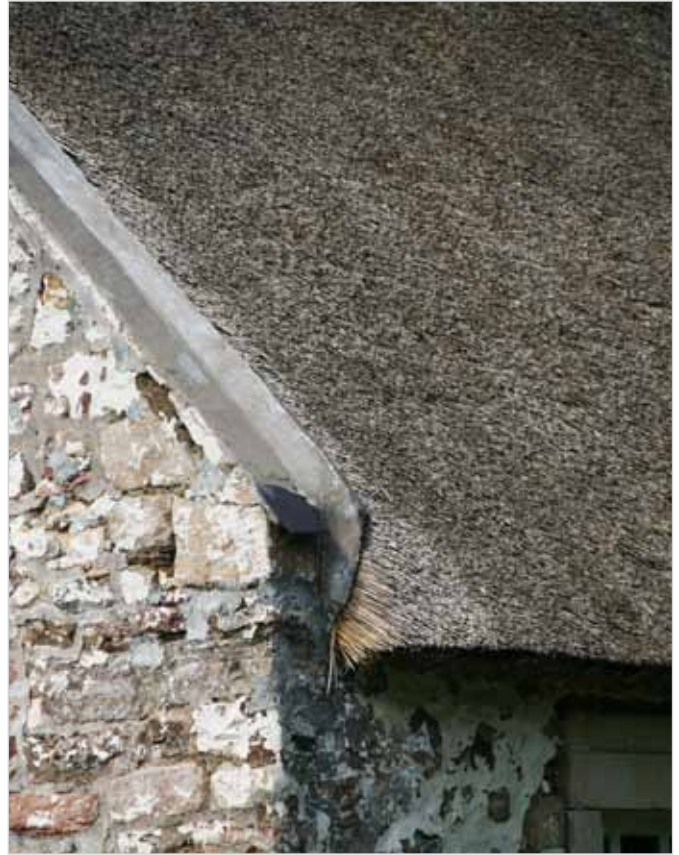
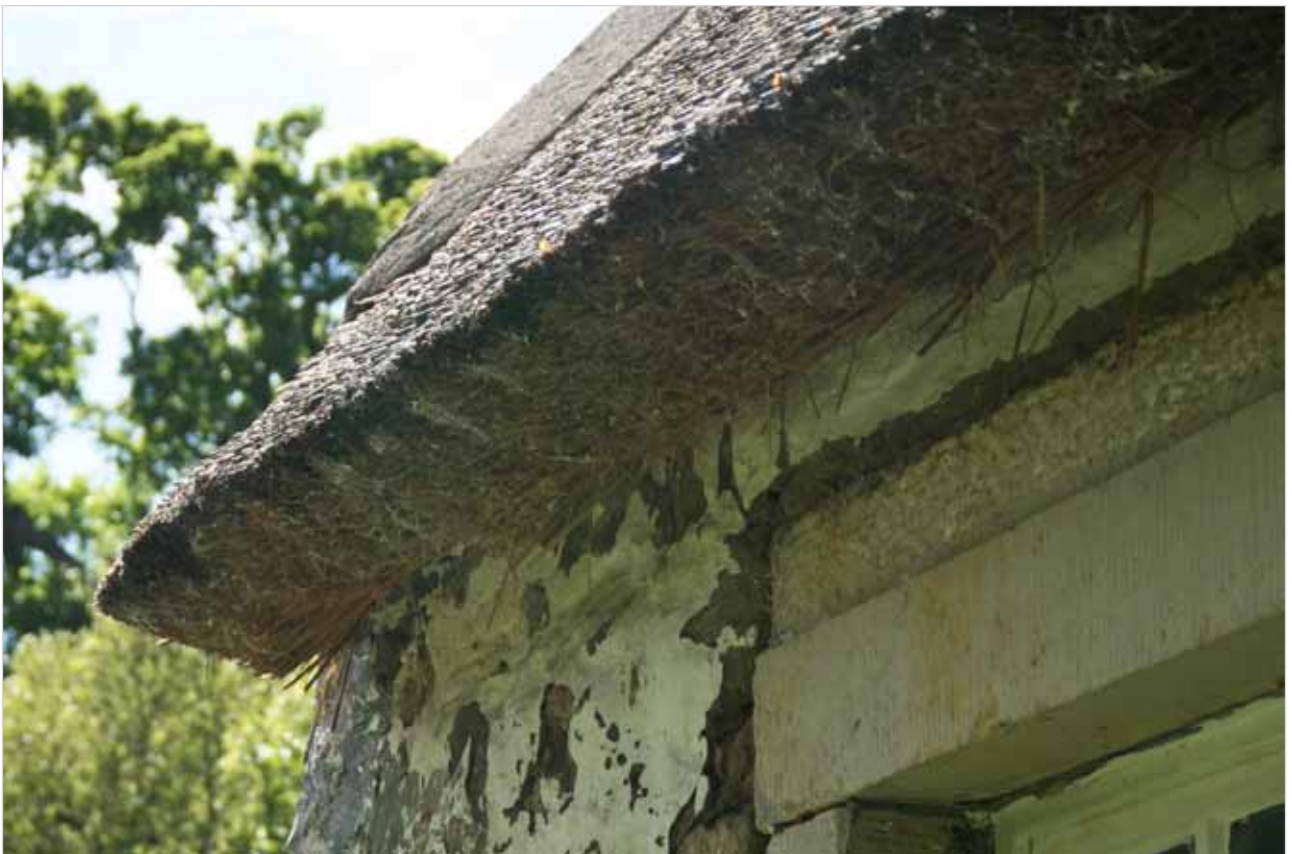
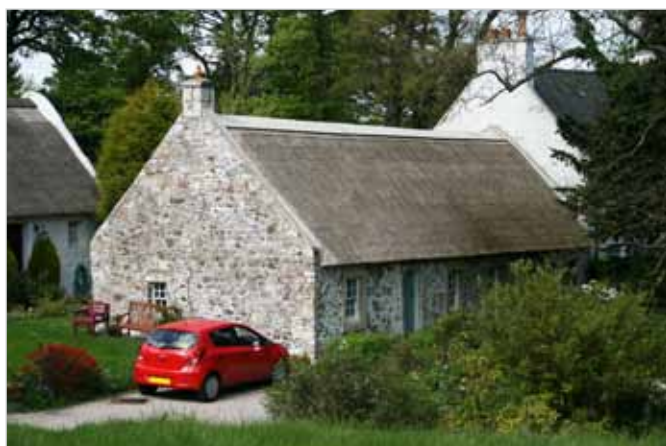
15 Swanston Village – Edinburgh

Condition of Thatch: ..... Good

thatch is extremely neat and is left entirely uncovered, and the concrete ridge appears in a new condition. Part of
